# Manhole Inspection Summary

Manhole # S39E2\_007MH

Insp Date: **1/2/08 10:16 AM**

**Location** Address: **4201 Townsend Ave**

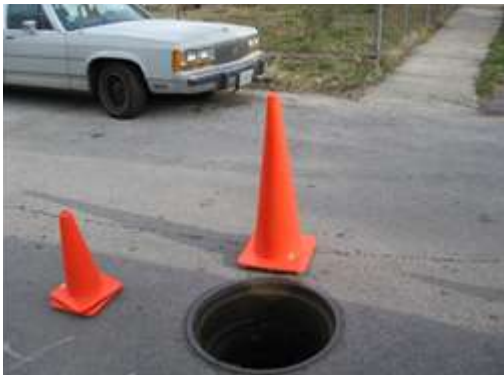
Location View

5th St & Hague Ave

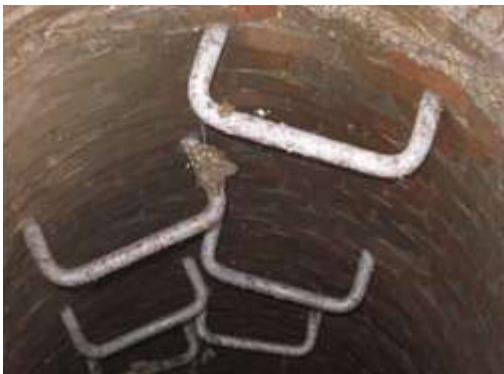
steps

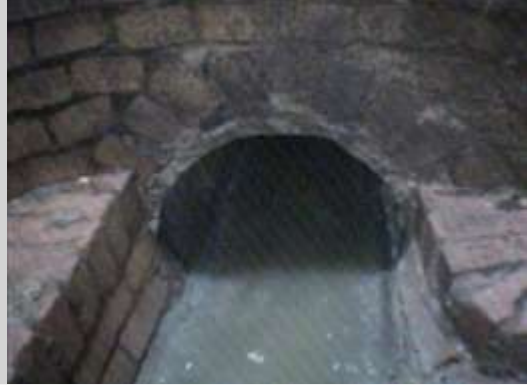
12 O'Clock Outflow

15 in. Circular Gravity Sewer  
Pipe Out @ 12 O'Clock

Pipe Height: **16.8** (in.) Rod and Bar (Angled)  
Pipe Material: **Clay** ☐ Pipe Lined  
Invert Depth: **13.68** (ft.) Flow Characteristics: **Fast**  
Deposits: ☒ None ☐ Mud ☐ Sludge ☐ Debris ☐ Grease  
Silt Depth: (in.) Deposits Extent:  
Infiltration: **None** Pipe Seal Cond: **Sound**

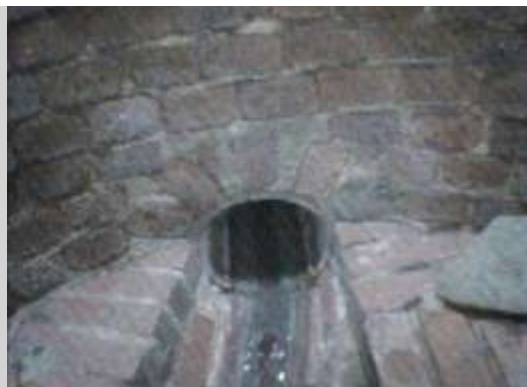
3 O'Clock Inflow

8 in. Circular Gravity Sewer  
Pipe In @ 3 O'Clock

Pipe Height: **10.8** (in.) Rod and Bar (Angled)  
Pipe Material: **Clay** ☐ Pipe Lined  
Invert Depth: **13.19** (ft.) Flow Characteristics: **Fast**  
Deposits: ☒ None ☐ Mud ☐ Sludge ☐ Debris ☐ Grease  
Silt Depth: (in.) Deposits Extent:  
Infiltration: **None** Pipe Seal Cond: **Sound**

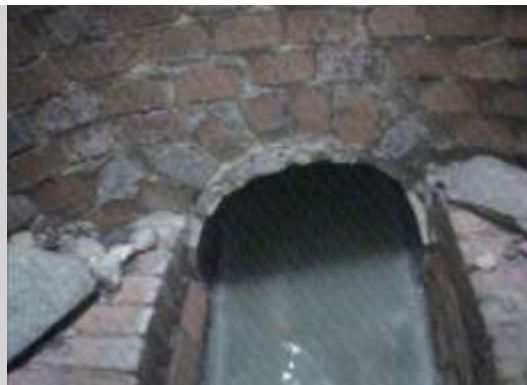
6 O'Clock Inflow

15 in. Circular Gravity Sewer  
Pipe In @ 6 O'Clock

Pipe Height: **15.6** (in.) Rod and Bar (Angled)

Infiltration: **None** Pipe Seal Cond: **Sound**
